User: **UWP Susan**

Response Id: **UWP Susan-7B8HYU**

Question	Answer
mWater Site Identification	
What type of Pre-Site Assessment is this?	Borehole Rehabilitation Wed, Feb 13, 2019 8:58 AM 0.4727674° 33.1950854°(+/-) 39.10499954223633 m
Has the Ugandan Water Project completed work at this site before?	No
Select a community/LC1 site from the map or create one if it is new.	Name: Kyamagwa Description: LC1 Location GPS Location: 0.472750, 33.195019 Administrative region: Mafubira, Mafubira, Butembe, Jinja, Uganda Location Accuracy: 0 mWater ID: 20007403
Is this potential borehole rehabilitation linked to a specific facility?	Yes
What type of facility is this?	Other (please specify) <i>Orphanage</i>
What is the name of this facility?	Lords Compassion Ministry
Is another facility type associated with this site?	No
ENUMERATOR: Please select or create the mWater site for this non-functional borehole	Name: Surface water, Kakete, Kyamagwa LC1 Type: Surface water Location GPS Location: 0.470170, 33.195669 Administrative region: Mafubira, Mafubira, Butembe, Jinja, Uganda Location Accuracy: 3 Location Altitude: 1147.83 mWater ID: 20007427 Photos:

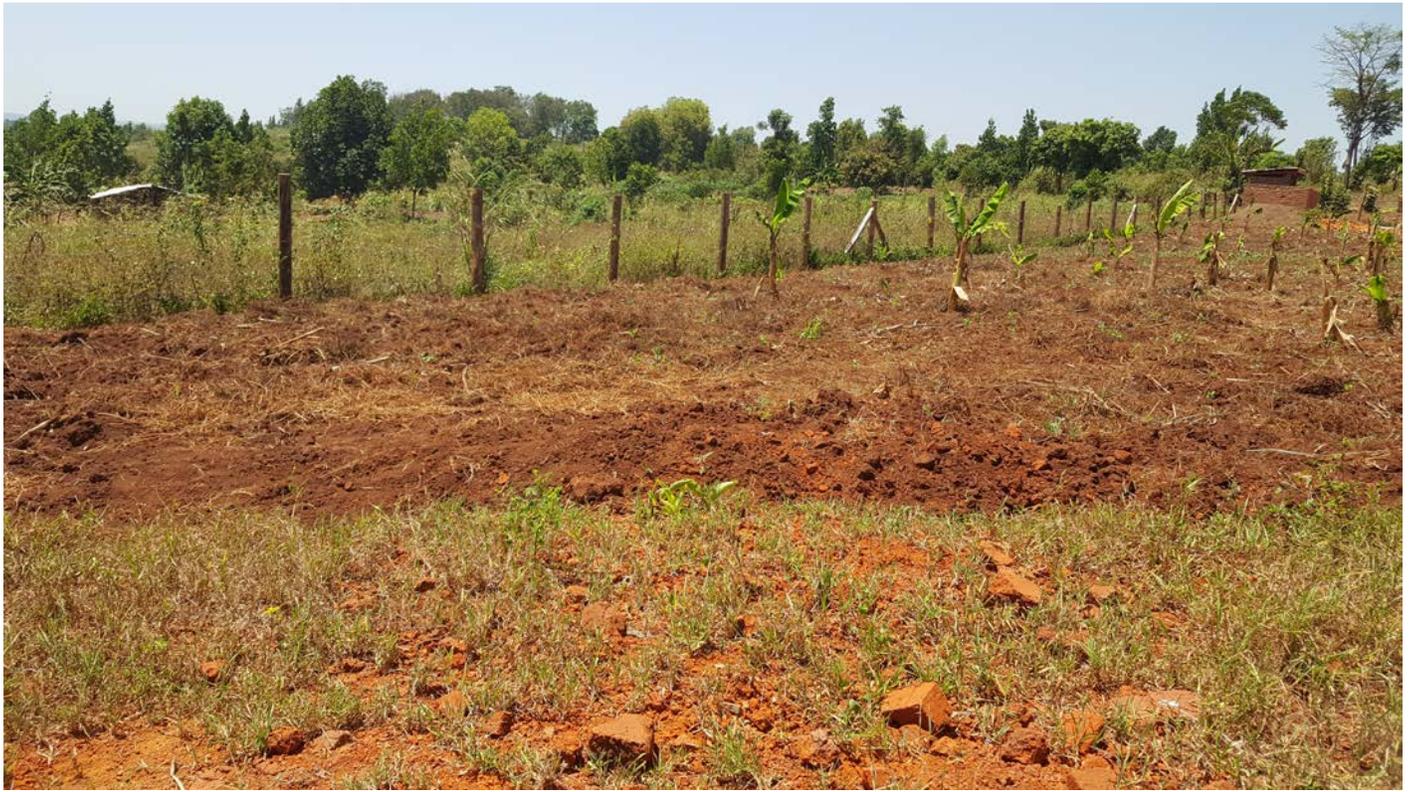
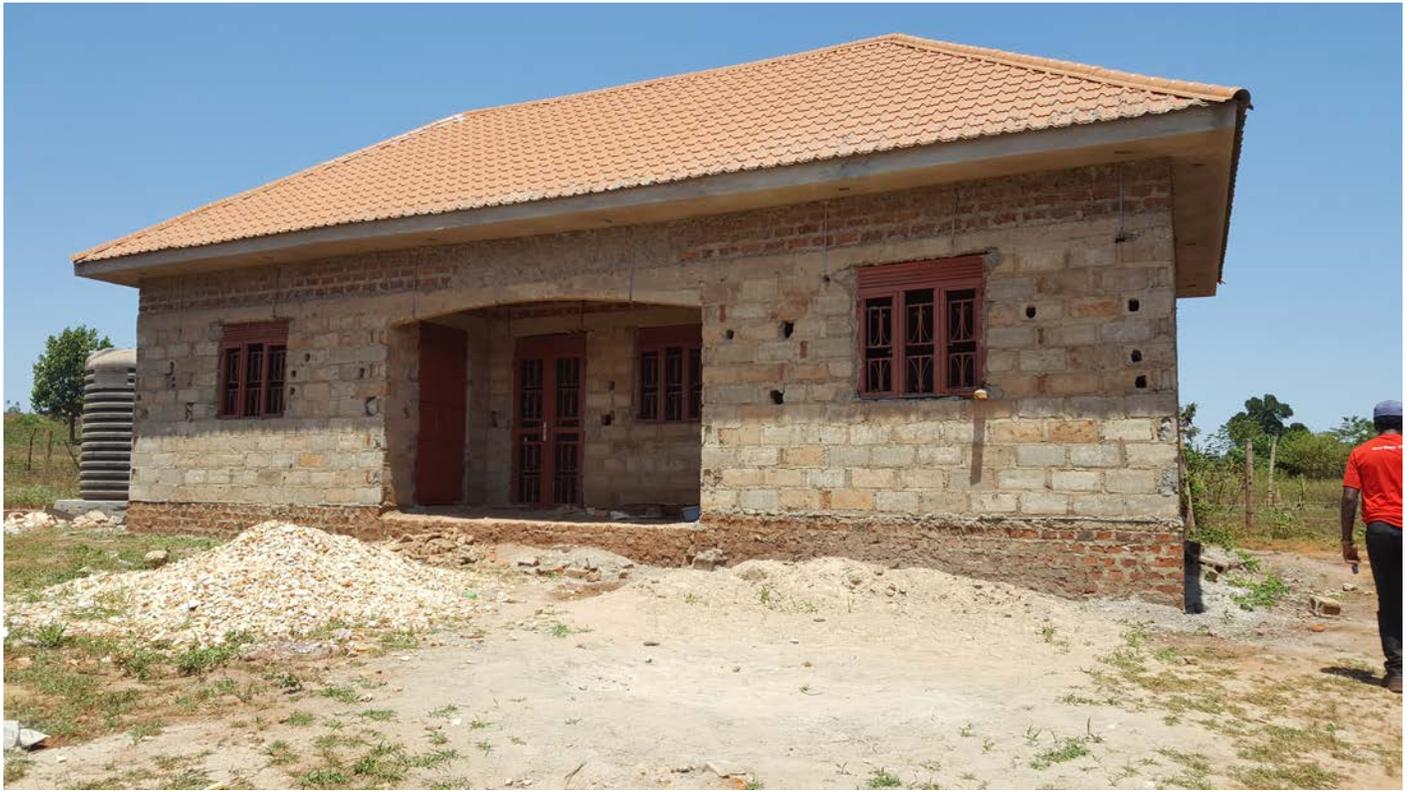
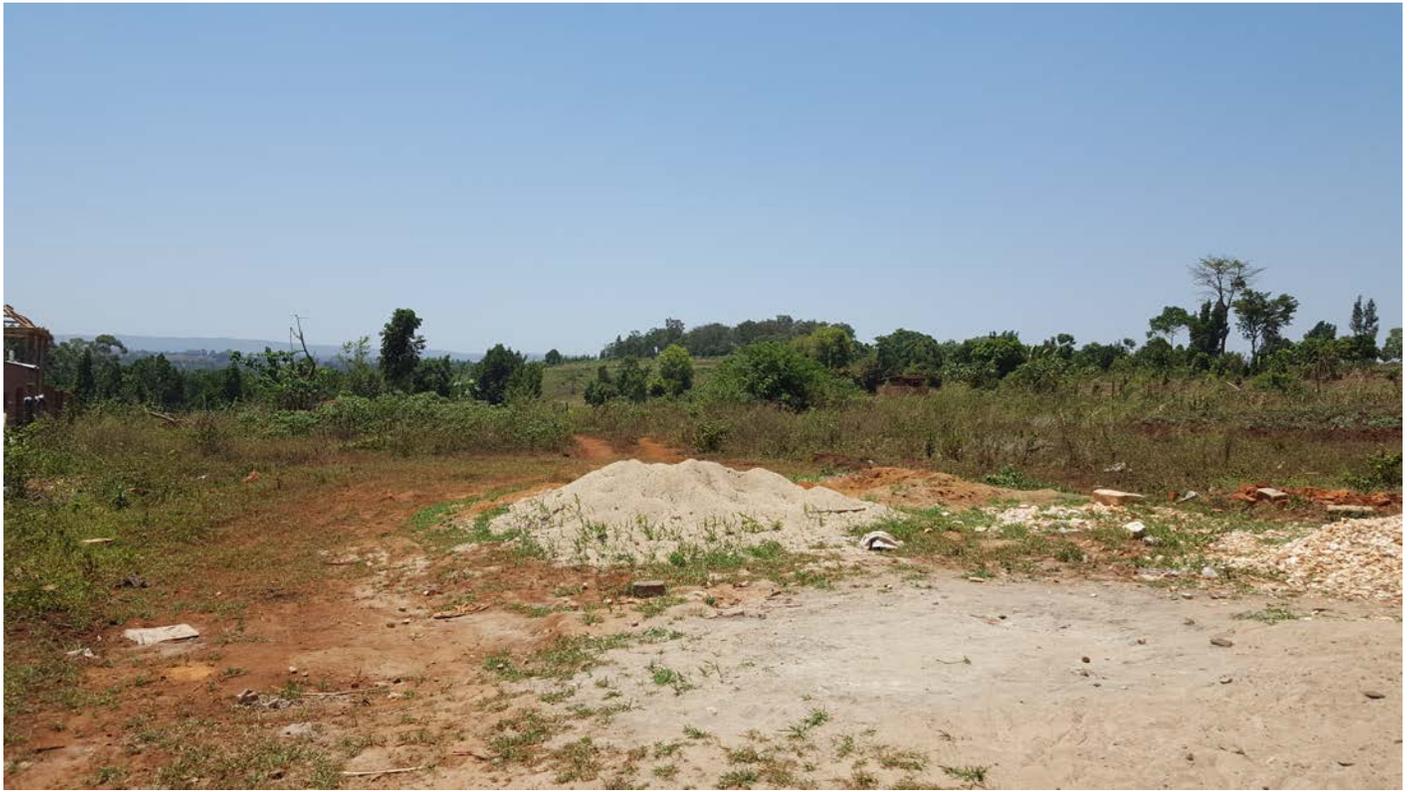
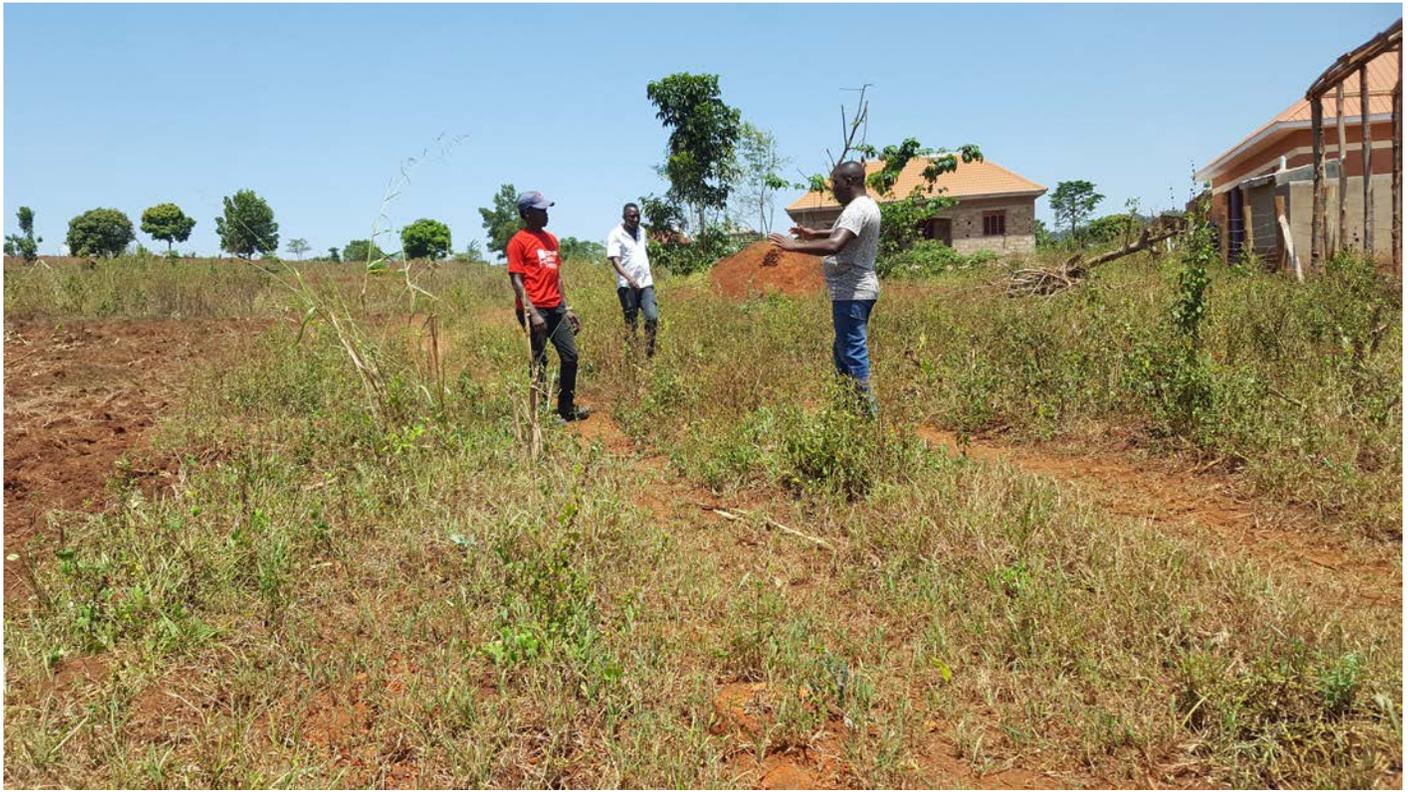
Question	Answer
How many people are currently using the ALTERNATIVE water source?	100
What relational value does this community bring to UWP?	Direct connection to UWP
What collaboration or networking value does this community bring to UWP?	Several contacts to collaborate with or network
BHR - Environmental Concerns	
How often is the ALTERNATIVE water source used by animals?	Animal owners use 1-3 times/week
What environmental concerns are associated with the conditions surrounding the ALTERNATIVE water source?	Steep slope Dense vegetation
BHR - Photographs	
The facility's sign with location name	
Community members smiling	
The borehole in need of rehabilitation

Surrounding terrain and barriers to borehole rehabilitation
