User: **UWP Susan**

Response Id: **UWP Susan-7B8HYU**

Question	Answer
mWater Site Identification	
What type of Pre-Site Assessment is this?	Borehole Rehabilitation Wed, Feb 13, 2019 8:58 AM 0.4727674° 33.1950854°(+/-) 39.10499954223633 m
Has the Ugandan Water Project completed work at this site before?	No
Select a community/LC1 site from the map or create one if it is new.	Name: Kyamagwa Description: LC1 Location GPS Location: 0.472750, 33.195019 Administrative region: Mafubira, Mafubira, Butembe, Jinja, Uganda Location Accuracy: 0 mWater ID: 20007403
Is this potential borehole rehabilitation linked to a specific facility?	Yes
What type of facility is this?	Other (please specify) <i>Orphanage</i>
What is the name of this facility?	Lords Compassion Ministry
Is another facility type associated with this site?	No
ENUMERATOR: Please select or create the mWater site for this non-functional borehole	Name: Surface water, Kakete, Kyamagwa LC1 Type: Surface water Location GPS Location: 0.470170, 33.195669 Administrative region: Mafubira, Mafubira, Butembe, Jinja, Uganda Location Accuracy: 3 Location Altitude: 1147.83 mWater ID: 20007427 Photos:

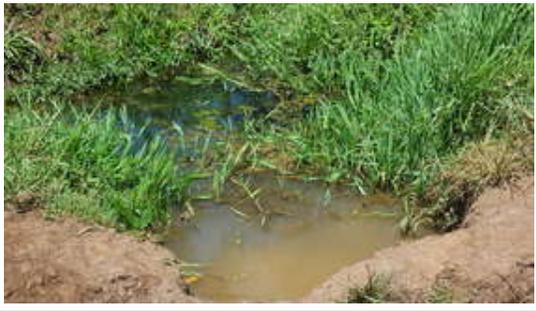
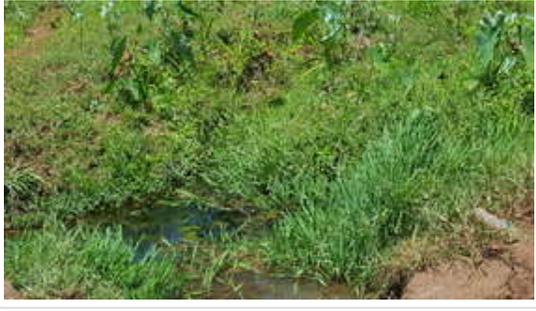
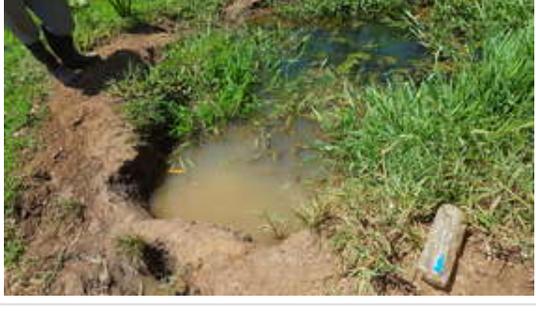
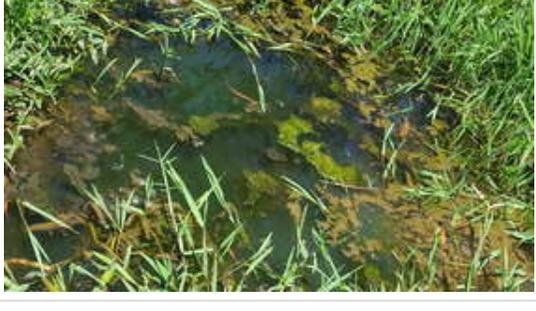
Question	Answer
How many people are currently using the ALTERNATIVE water source?	100
What relational value does this community bring to UWP?	Direct connection to UWP
What collaboration or networking value does this community bring to UWP?	Several contacts to collaborate with or network
BHR - Environmental Concerns	
How often is the ALTERNATIVE water source used by animals?	Animal owners use 1-3 times/week
What environmental concerns are associated with the conditions surrounding the ALTERNATIVE water source?	Steep slope Dense vegetation
BHR - Photographs	
The facility's sign with location name	
Community members smiling	
The borehole in need of rehabilitation
